Shadow Paintings: A Neglected Type of Wall Painting

Elisabeth Andersen & Susanne Kaun

NORDISK TIDSKRIFT FÖR BILDTOLKNING • NORDIC REVIEW OF ICONOGRAPHY

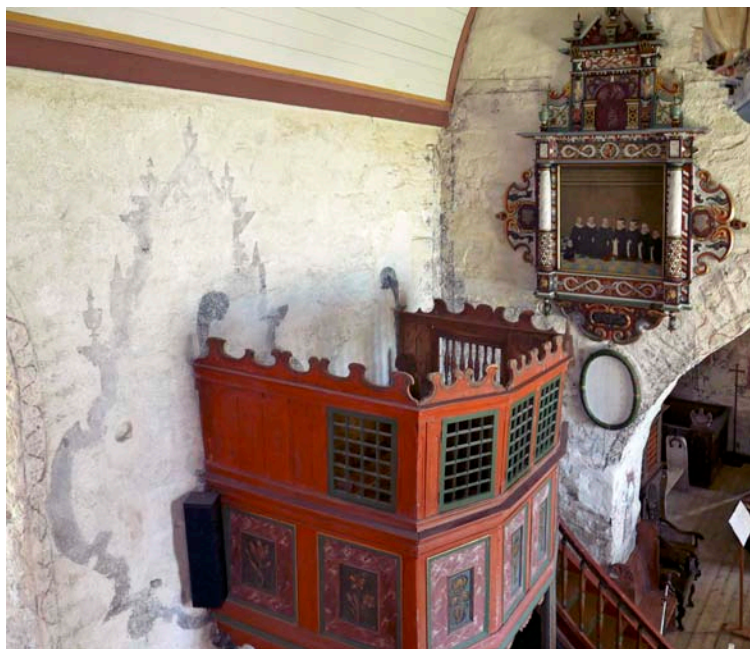
Fig. 4. Dale Church in Luster, Sogn og Fjordane. The abandoned shadow painting on the north wall (left in the photo) belongs to the epitaph from 1630, hanging on the north side of the chancel-screen (top right on the photo). Photo Susanne Kaun, NIKU.

In Dale Church, three painted shadows have been preserved; they were paired with an earlier altarpiece (as noted above), a stall and an epitaph since moved. The epitaph is from c. 1630, but the wings were

probably mounted later, around 1650.²¹ Given that the shadow follows the shape of the epitaph's wings, the shadow must have been painted in connection with this remodeling.

In 1699, to make room for a stall, the epitaph was moved from its original place, on the north wall of the nave, to the north side of the chancel-screen, where no new shadow was painted (fig 4). However, a shadow
